Conservation of Cairo Historic parks Towards better quality of life

4. Case study: The Japanese Park:

4.5. Current condition survey:

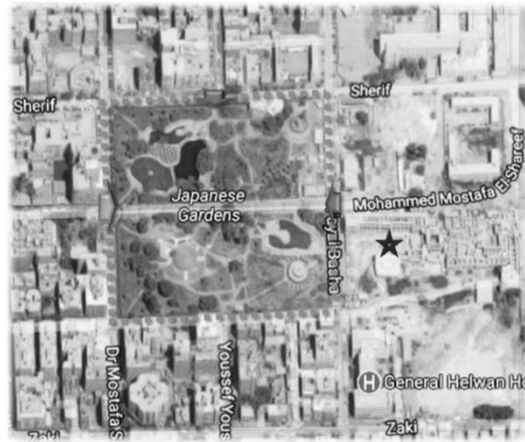
Fig.3. Japanese garden Layout

The park located in the east part of Helwan and surrounded by 4 streets, Dr. Mostafa Safwat St. from the west, Fezy Basha from the west, Shereif St. from the north and Mohamed saied st. from the South. The park has 3 entry gates, the main entrance from Mostafa Safwat St. and two secondary entrances, first one is side entrance from Sherief St. and always closed, the other one is opposite to the main entrance from Fezzy St.

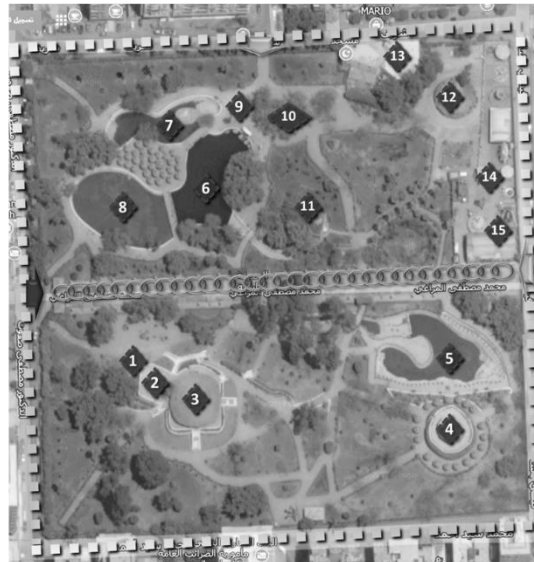
Fig.4. Japanese Park main elements

4.3.1. The right side: is the most interesting part. As soon as you enter and turn right, you will see a huge Buddha face carved out of a rock "Life face". If you walk up, you will reach a plateau encompassing a fountain with three little elephants. The fountain, as most waterways in this park, is dry. Right next to it is a Japanese cottage "Life kiosk" where you can rest on some of the benches. From here on, keep walking straight up the hill until you come across what used to be a lake surrounded by 48 Buddha statues. Above the lake with the Buddha statues, there is another Kiosk functioning as a panorama.

4.3.2. The other side of the park also has lakes, which were dry except one lake. There is a collection of paddle boats in this lake. Next to a little bamboo forest, there is a big smiling Buddha statue. At the end of the park is another Japanese cottage with benches. To the right of that is an amusement park. Apart from the bamboo, there aren't other Japanese flowers or trees to be found.

- ▀ Main Entrance
- ◻ Secondary Ent.
- ⊙ Main spin
- ▬▬▬ Surrounding streets
- 1. face of life statue
- 2. fountain with three little elephants
- 3. Japanese kiosk
- 4. Arabic kiosk “panorama”
- 5. lake surrounded by 48 Buddha statues
- 6. lake of paddle boats
- 7. Ship lake
- 8. Lutes lake
- 9. Buddha statue
- 10. little bamboo forest
- 11. Administration
- 12. Music kiosk
- 13. Mosque
- 14. Services
- 15. Amusement park

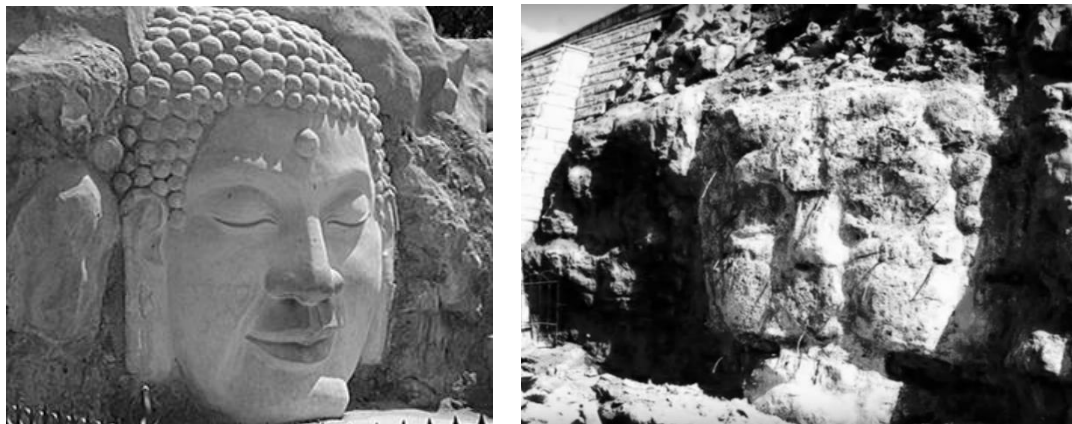
Fig.5. The statue of “Face of life” before and after restoration

The park was suffering from the neglect and degradation of all elements, which distorted its distinctive historical character. Cairo Governorate prepared a project for the development restoration of the park in 2004. The management of the specialized gardens has supervised the work, where the work started in January 2005 and completed in June 2006 with a cost of five million five hundred thousand pounds. The project attempted to restore the original image of the garden through the restoration of the outer fences, pergolas and statues, Repairing the garden infrastructure of electrical connections, drainage networks and irrigation (Specialized Parks Management, 2006).

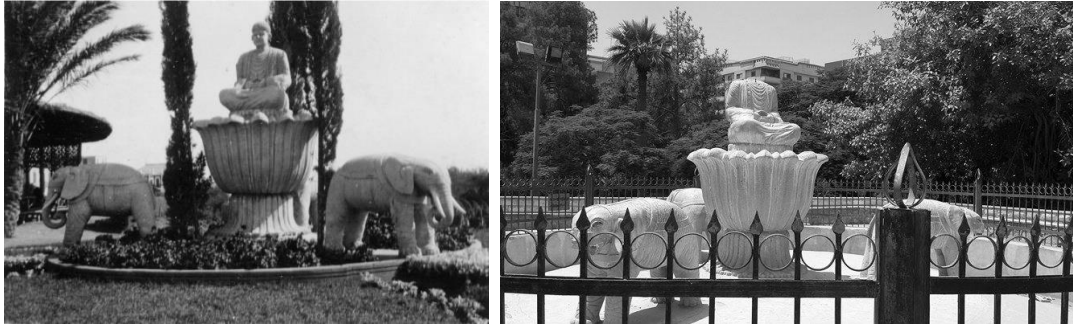
Fig.6. Before and after adding the iron fence

The visual separation resulting from the construction of an iron fence around all architectural elements within the garden such as statues of students, Buddha statue, the face of life and the statue of Zulfakar Pasha and elephants.

- Removing all iron fences that were added around the park elements and using alternatives such as cactus plant or spiny plants in general.
- Place signs inside the park to inform visitors about the existing historical trees to clarify the history, the original place, the scientific name and some information about them.

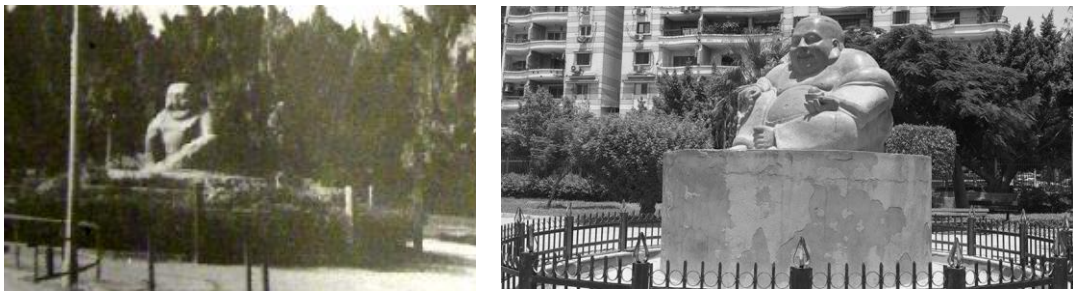
Fig.7. The change in proportion after restoration

Change in proportion after restoration: The proportions of some statues were changed during the restoration process. Such as Buddha statue, it differed from the origin that existed in this place since the time of the establishment of the garden. The statue recently restored randomly that led to change of the size and shape of the statue. The height of the base increased 3 times the height of the original and swallowed the feet of the statue and a large part of the body, resulting in the loss of many of its original features (Shebl, 2012).

- Restoration of the statues according to the correct foundations and by specialists, and using modern techniques to resist destruction by users, considering restoration of the element to its original form.

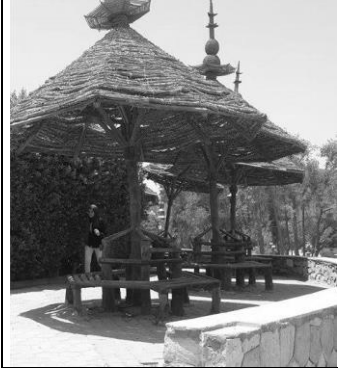
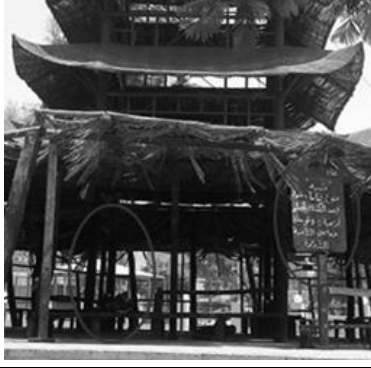
<p>Climatic comfort: pergolas provide shaded areas for sitting</p> <p>Privacy: There are many pergolas in different zones for sitting that offers some privacy.</p>	<p>maintenance Poor maintenance of pergolas as other park elements</p> <p>Cleanness No trash bins are available in pergolas where users sit.</p>	<p>Safety: Some pergolas are not safe, such as Japanese kiosk. Although there is a warning sign of the danger of sitting under the tower, but users use it without any control or supervision.</p>

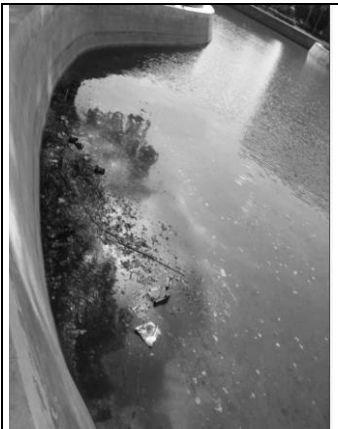
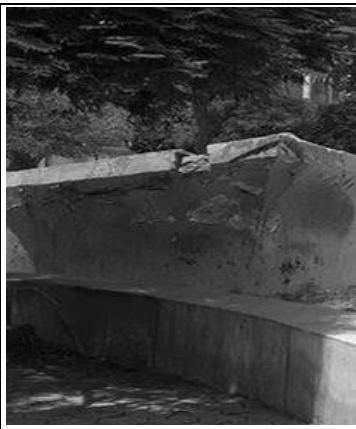
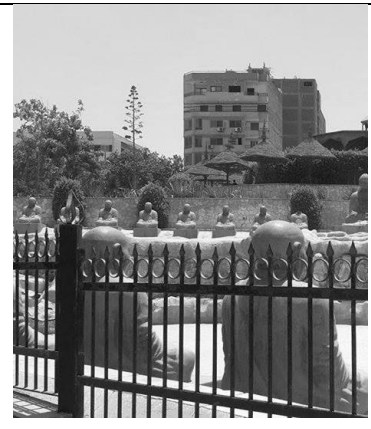
Water is one of the main elements in the design of the park, where it occupies the largest area among the elements of the garden. There are 4 lakes: Lotus lake, Ship lake, pedals lake and students' lake. Water is the design element that creates the integration between two sides of the garden as it continues under the level of the main street, which divides the garden. Most of the water features are dry except the pedal lake which filled with Stagnant water that may contain harmful bacteria.

<p>Stagnant water in the Pedal lake is found.</p>	<p>Cracks in the external surface of the ship inside the lake.</p>	<p>The iron fence around students' lake Causes visual separation.</p>

- Develop periodic plans for cleaning lakes, water filtration or water change.
- Place a guide board next to the park entrance showing the main areas of the park and how to reach them.

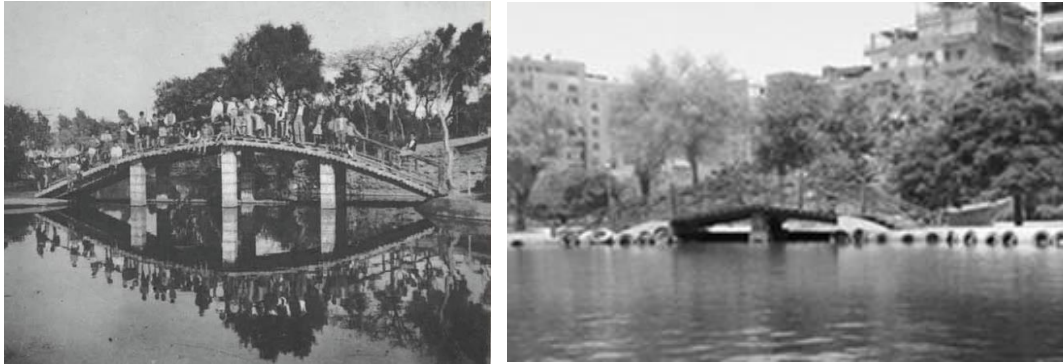
Fig.8. Original vs. current status of the wooden bridge

Many plans have been implemented to return the lakes to the state of their aesthetic and historical appearance as in Fig1), which illustrates the lake and the wooden bridge above, made of decorated wood in 1920. The bridge was replaced and re-established and has changed in form and area of the original form as in Figure

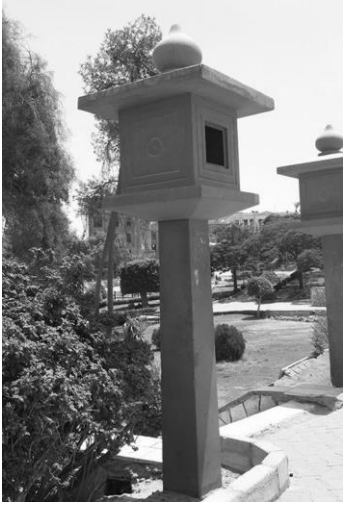
Most of the landscape furniture elements are not the original ones and added during restoration project without referring to the original design. All the furniture elements suffer from poor maintenance. No anti-vandalism design is applied in site furniture.

<ul style="list-style-type: none"> - the design not related to the park character - Many seats are shaded by pergolas or canopy trees. - Seats are well distributed in the park. 	<p>The lighting network that was inside the park was completely changed and new units were installed within the garden renovation plan.</p>	<ul style="list-style-type: none"> - the design not related to the park character. - The number of trash bins is not equivalent to the park area and not well distributed. - No recycling system.

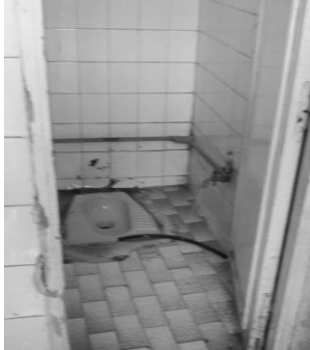
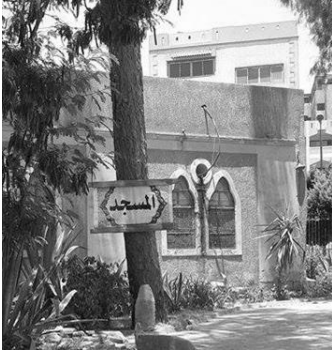
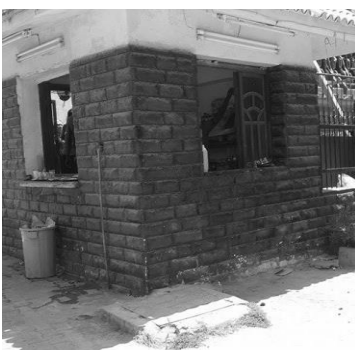
Toilets	Prayer area	Cafeterias

Unclean toilets, Poor maintenance Not enough toilets	There is a mosque in the park	Only one cafeteria is found
