# Fabry-Perot Sensors for the Monitoring of FRP Reinforced Bridge Decks

B. Benmokrane\*<sup>a</sup>, M. Quirion<sup>b</sup>, E. El-Salakawy<sup>a</sup>, A. Debaiky<sup>a</sup>, T.Lackey<sup>c</sup>

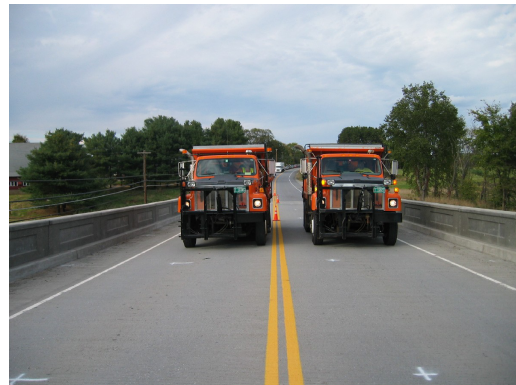
Figure 3: Field testing of Morristown Bridge.

The bridge was tested for service performance (October 2003) under static loads using two calibrated truckloads with three axles each as shown in Figure 3. Four paths, two in each direction, corresponding to the direction of each with seven stations (truck stops) were marked along the longitudinal direction of the bridge to give critical loading cases and influence lines at the instrumented section of the bridge (mid-span). The test was carried out using a single truck over the four paths and the two simultaneously along one path for a total of 35 (7 stations  $\times$  5 paths) readings were recorded for each gauge. Results were presented in a strain position-plot shown in Figure 4 below for two FOS on transverse bars. The maximum value on the horizontal axes represents the location on the bridge that contains the gauge under consideration (mid-span). In case of one truck, the maximum measured strains in bottom and top FRP bars were 31 and 4 micro-strains, respectively. These values show the sensitivity of the FOS and their ability to function under low strains. In addition, the sensors were proven to be rugged enough to withstand the conditions of concrete cast, placing, and curing. Attaching the FOS to GFRP bar surface was also proven to be a valid procedure. The bridge was then tested for dynamic response under real traffic conditions. The maximum-recorded strain values in FRP reinforcement were in the same order as for the static tests as shown in Figure 5. Further details of the interpretation of the static and dynamic data of the Morristown Bridge are provided by Benmokrane et al. (2003).

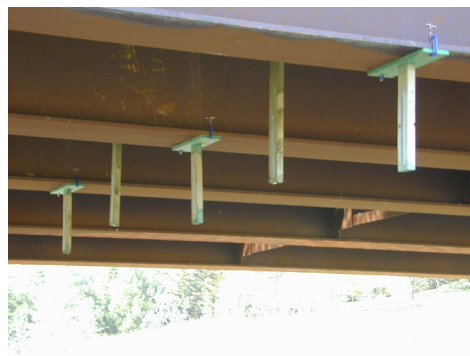
Figure 6: Rulers installed on steel girders to measure deflection.

During static tests, deflections of concrete slabs and steel girders were measured by a theodolite using a system of rulers installed at the mid-span as shown in Figure 6. The maximum measured deflection on the steel girders at the mid-span of the bridge due to truckloads at different paths as shown in Figure 7. In case of one truckload, the two intermediate girders directly underneath the truckload carry 55 to 60% of the total load, while the other three girders away from it carry 40 to 45%

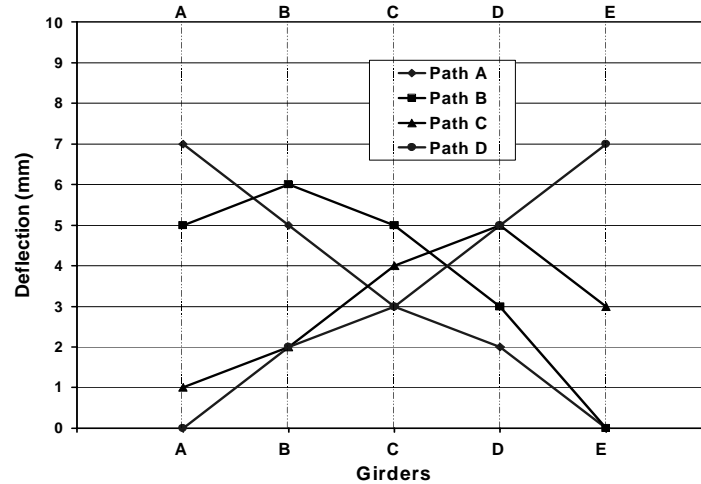
Figure 7: Maximum measured deflection of steel girders (Truck at bridge mid-span)

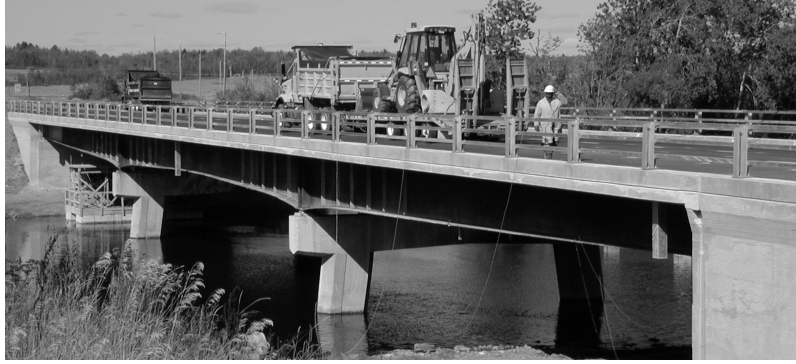
Figure 8: Magog Bridge – on Highway 55 North, Québec, Canada

The bridge is a girder type with a total length of 83.7 m and five main steel girders continuously supported over three spans as shown in Figure 8. The two end spans are 26.2 m each and the middle one is 31.3 m. The deck slab is continuous over four spans of 2.845 m each with an overhang of 1.352 m on each side as shown in Figure 9. Clear concrete covers of 35 and 60 mm at bottom and top, respectively were used. One full end span of the deck slab was reinforced with FRP bars. The other two spans were reinforced with galvanized steel. The concrete deck slab was designed according to Section 8 of the Canadian Highway Bridge Design Code (CHBDC, 2000) for steel reinforcement, which was then replaced with FRP bars according to Section 16 of the same code in one end span. The resulting FRP reinforcement was glass FRP (GFRP) bars (No.16 at 15.9 mm) in all directions, except the short direction at the bottom, where carbon FRP (CFRP) bars (No.10 at 9.5 mm) were used. The bridge is well instrumented with fiber-optic sensors at critical locations to record internal temperature and strain data. These sensors have monitored deck behavior since bridge construction (September 2002) and will continue to do so for several years. Also, the bridge was tested for service performance using standard truckloads as specified in the new CHBDC (2000).

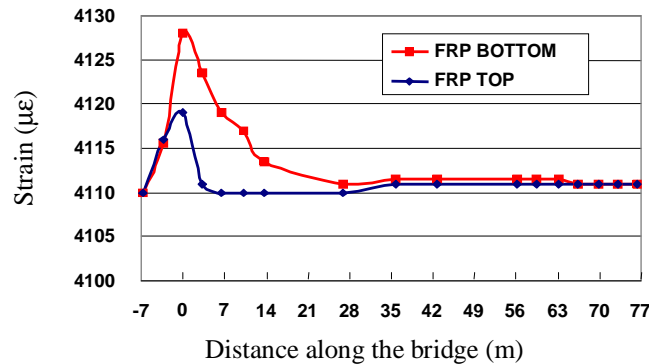
Figure 10: Change in strains in FRP bars due to truck load (static testing).

The bridge was tested on October 2002 under both static and dynamic loads traveling in five transverse positions and two combinations of truckloads. Results were presented in a strain position-plot shown in Figure 10. The zero value on the horizontal axes represents the location on the bridge that contains the gauge under consideration. In case of two trucks (maximum expected load at most critical position), the maximum measured change in strain in bottom and top FRP bars due to truck load were 18 and 9 micro-strains, respectively.

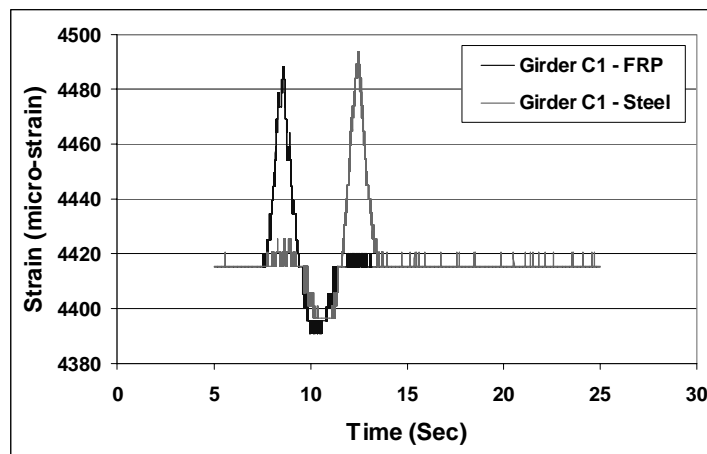
Figure 11: Change in strains in steel girders (Two trucks over Path C-E - 50 km/hr).

For the dynamic testing, the trucks traveled at four different speeds of 5, 30, 50, and 70 km/hr. The maximum-recorded change in strain in FRP reinforcement due to truck load was in the same order as for the static tests. The peak strains measured on the steel girders were very similar, if not exactly the same, for FRP-reinforced and steel-reinforced spans for the same truck speed and path. Figure 18 shows the tensile strains measured in steel girder C against time for the two trucks traveling simultaneously on Path C-E at a speed of 50 km/h. In this figure, the two graphs represent the response of the same girder (C) measured at the middle of the two end spans while the truckloads were moving across the bridge. Note that the measured peak strains on the steel girders were -25 and +73 micro-strains. For Truck No. 2 with the trailer traveling on Path C at a speed of 5 km/h and 50 km/h, the strain values were -20 to +35 and -15 to +35 micro-strains, respectively. These strains correspond to stresses of - 4, 7, - 3, and 7 MPa. Further details of the interpretation of the static and dynamic data of the Magog Bridge are provided by El-Salakawy and Benmokrane (2003).
