EXPERIMENTAL STUDY ON THE REHABILITATION OF CORRODED REINFORCED CONCRETE BEAMS USING FIBER REINFORCED POLYMER

A. S. Debaiky 1, Hala.M.R.Abusafa 2, Marwa H. Bondok 3*

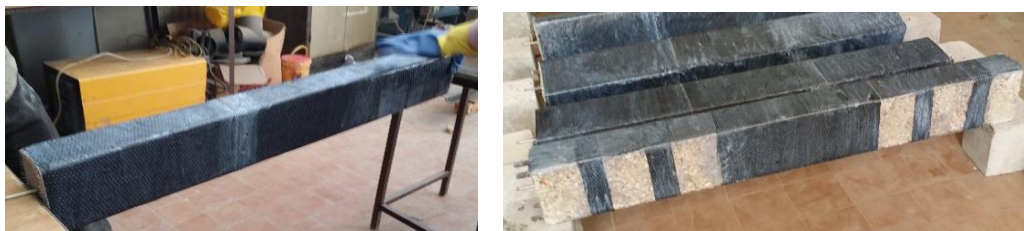
Fig.7: Illustrated the repair and strengthening of specimens in the laboratory.

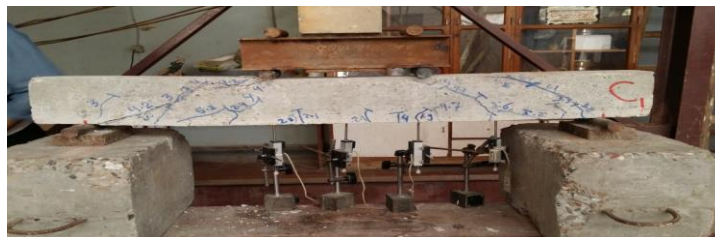
Fig.8: Preparation of Test Specimens

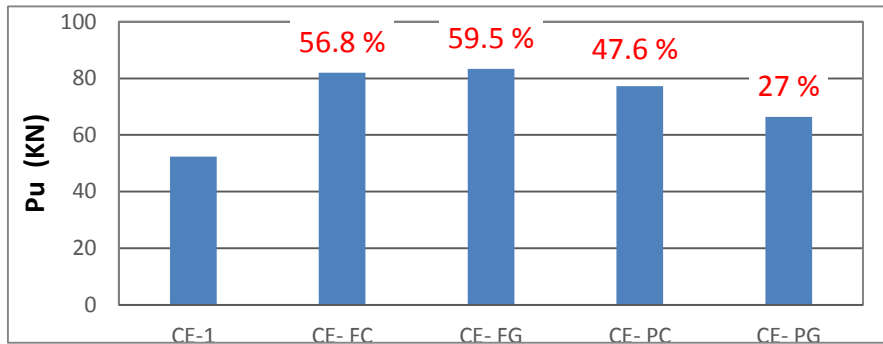
Fig. 9: Ultimate Load Comparison of Beams.

The above result show that the ultimate capacity of the R.C beams strengthened by external CFRP wrapping is greater than beams strengthened by GFRP in (scheme II), full wrap specimens over the length (scheme I) give Results higher than part wrap specimens (scheme II),but, Scheme II give significantly improved in the ultimate load capacity as shown in Fig. 9 .

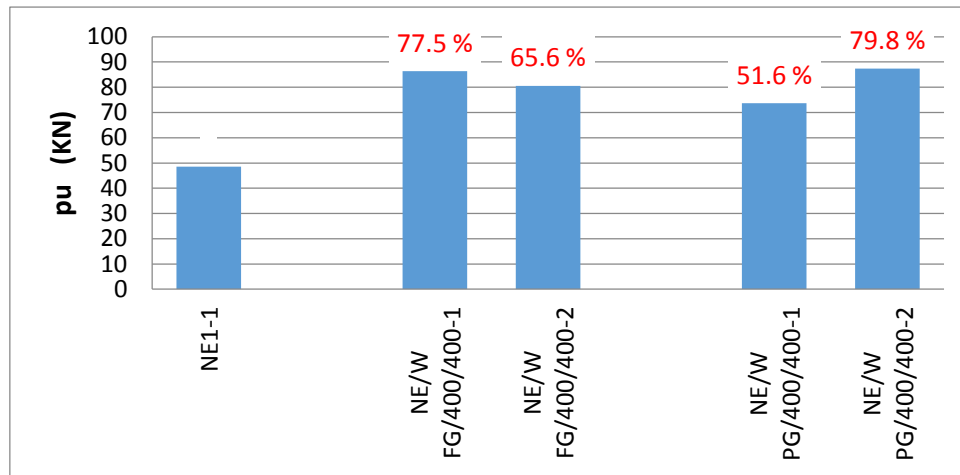
Fig.12: Ultimate Load Comparison of Beams.

The above results show that the ultimate capacity of the R.C. beams repaired by external GFRP wrapping is greater than the control beams and greater than corroded unwrapped beam by average 71.55 % for (scheme I) and 65.7 % for (scheme II), full wrap specimens over the length (scheme I) give Results slightly higher than part wrap specimens (scheme II).

Scheme II give a major increase and significantly improved in the ultimate load capacity, lower in cost, and easy in application, therefore it is preferred to use it in retrofitting the ultimate capacity of natural corroded beams as shown in Fig. 12.

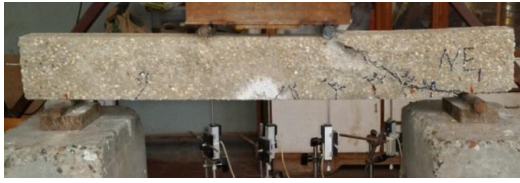
fig.23: shows failure mode of un wrapped

UN wrapped, all beams failed by shear failure with diagonal tension cracks increasing in ultimate load to fracture in the concrete at one sides as shown in fig.23.

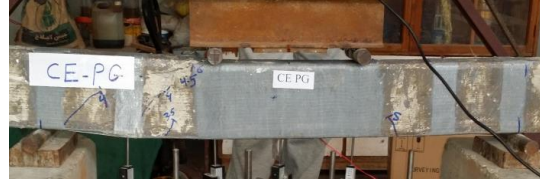
(b) shear failure

fig.25: shows the failure mode of scheme II.

Scheme II, Some of beams after wrapping failed by flexure failure in middle span between two points of loading by fraction in concrete and fibre. As the applied load increased, the developed cracks propagated rapidly from the tension side towards the compression side as shown in fig.25. (a), and others failed by shear failure with diagonal tension cracks increasing in ultimate load to fracture in the concrete at one sides as shown in fig.24. (b).The failure mode of all beam specimens indicated in table.2.
